Citation style: Stan-Kłeczek Iwona, Stan Dominika. (2019). Application of the ERT to recognise the geological structure of frost-riven cliffs localised in the Skalny Potok (Hrubý Jeseník Mts.). "Acta Geophysica", (2019), t. 67, p. 1759–1764, doi 10.1007/s11600-019-00329-8

Application of the ERT to recognise the geological structure of frost-riven cliffs localised in the Skalny Potok (Hrubý Jeseník Mts.)

Iwona Stan-Kłeczek¹ · Dominika Stan¹

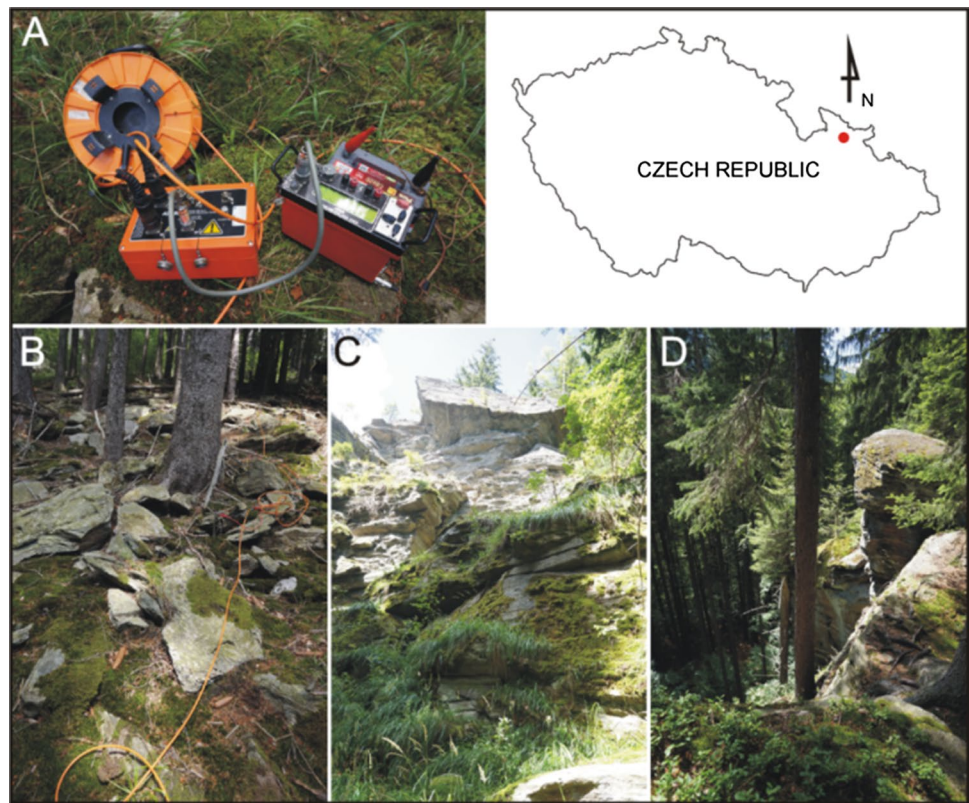
Fig. 1 Localisation of the Skalní Potok Nature Reserve in Czech Republic. **a** ABEM Terrameter LUND Imaging System, **b** ERT profile, **c**, **d** examples of cliffs

The Skalni Potok Nature Reserve is located within the highland range of Hrubý Jeseník Mts. (Eastern Sudetes) in geomorphological subunit the Medvědská hornatina and vicinity of west of Vrbno pod Pradědem (Fig. 1).

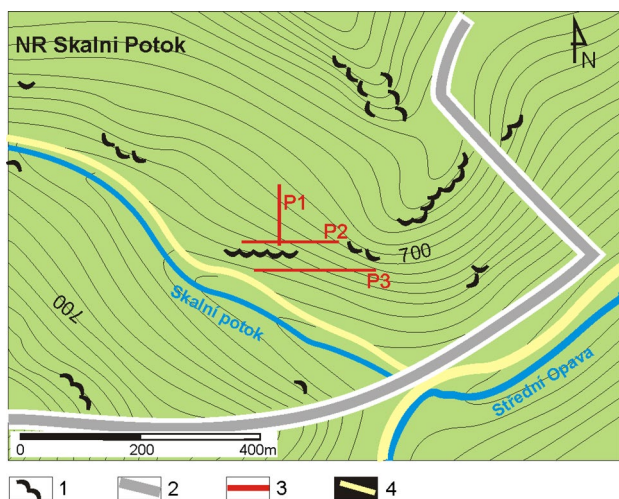
Fig. 2 Location of ERT profiles: 1- frost-riven cliffs, 2- the boundary of the Skalni Potok Nature Reserve, 3- ERT profiles, 4- roads

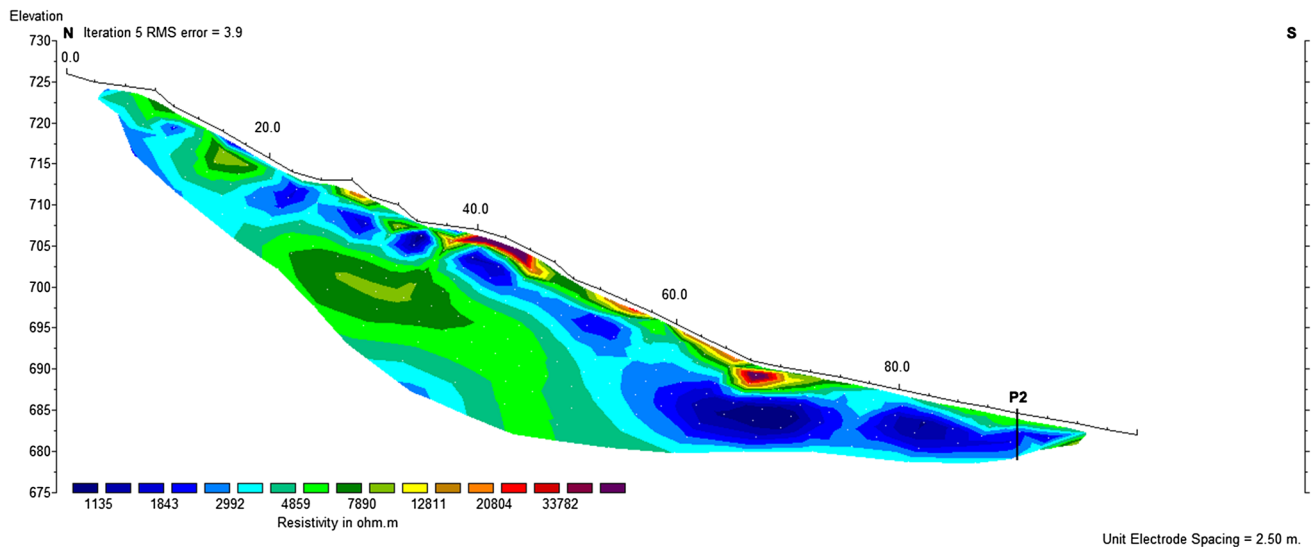
Fig. 3 Electrical resistivity tomography of the profile P1

The first, near surface layer with the electrical resistivity from 9 to 12 k Ω m (Fig. 3) is a layer consisting of blocks partially filled with air (the middle part of the profile). In the remaining part, loosely packed rock material was stabilised with fine-grained material and partially covered with vegetation. The next layer with the electrical resistivity values from 1.2 to 3 k Ω m has a diversified thickness, strongly cracked and is also a layer of infiltration of water initiating further development of erosion processes. The third layer with the electrical resistivity of 4 to 9 k Ω m is less cracked. The P1 profile perpendicular to the P2 profile intersecting it at 68 m represents a three-layer rock mass.

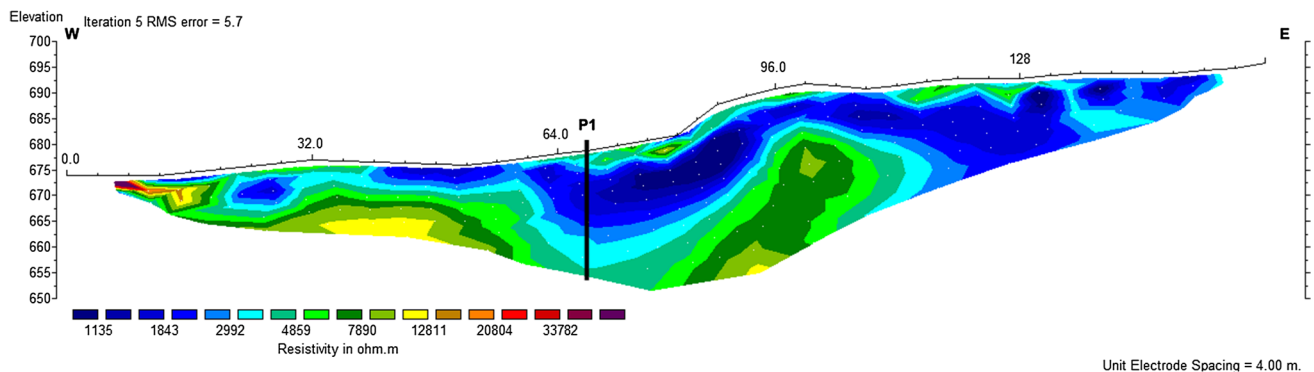
Fig. 4 Electrical resistivity tomography of the profile P2

The P2 profile made on the roof of the cliff has a two-layer structure of the rock mass (Fig. 4). The first layer with the electrical resistivity from 1.2 to 3 k Ω m achieves an average thickness of up to 15 m. The thickness of this layer increases from 120 m, which is related to the thickening of the vegetation cover, in particular woody, which is represented by decreasing electrical resistivity values. The middle part of the profile lens of much smaller resistivity values (0.7–1 k Ω m) than the surrounding medium can be noticed pointing to water infiltration. At the beginning of the profile, the electrical resistivity values above 11 k Ω m can

be observed. They are connected with the occurrence of a fracture of up to 15 cm opening, separating the cliff. The first layer is underlain by a less cracked layer with the electrical resistivity values up to 9 k Ω m.

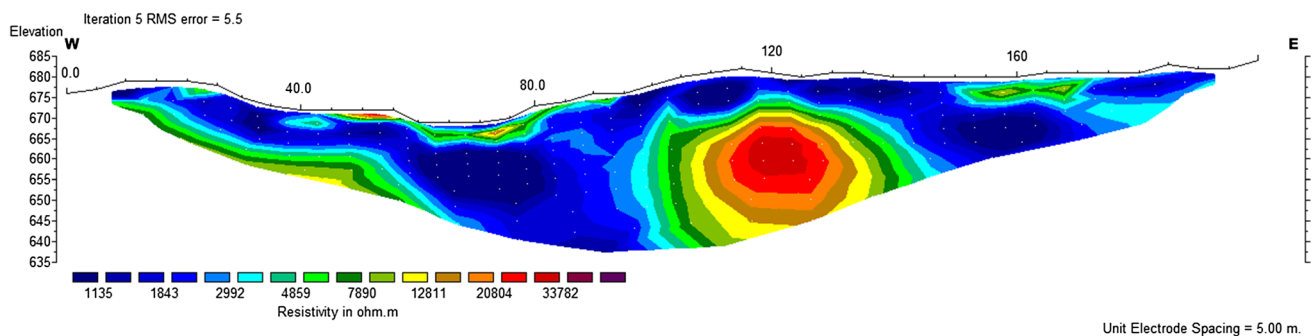
Fig. 5 Electrical resistivity tomography of the profile P3

The P3 profile was located parallel to the P2 profile at the foot of the studied cliff. The length of the profile was 200 m and the depth was up to 40 m. The floor of weathered layer was not reached (Fig. 5). Despite the fact that the profile

was carried out at the foot of the slope, the thickness of the weathering cover (regolith) did not exceed 40 cm (compare with Stan and Stan-Kłeczek 2014) confirming the high activity of recent slope processes in the studied area. Compared to previous profiles, the P3 profile does not have a layered structure. The layer with the electrical resistivity from 1.2 to 3 k Ω m is dominant. On its surface, remains of the 4 k Ω m layer are visible as a less cracked layer (see profiles P1 and P2). Similarly, to the P2 profile, the waterlogged places are noticeable as an accumulation of water feeding neighbouring watercourses. In the central part of the profile, the intrusion of the metagranitoid with a high quartz content with the electrical resistivity values above 15 k Ω m is most likely recognised. The changes in the measured values of the electrical resistivity on the Skalni Potok cliffs are related to the degree of weathering of the stratum, that is, the compact distribution of cracks and the occurrence of water within the rock layer, as well as the intrusion of quartz intrusions occurring within them (Martín-García et al. 2015). On the P1 and P2 profiles made on the cliffs, the cracks zone has a smaller thickness than at the foot of the cliff, which is a water reservoir transported down the slope. The activation of both primary (tesktural) and secondary (tectonic) areas of discontinuity in directly exposed outcrops depends both on temperature and humidity. The gneiss occurring in the studied area, as a crystalline rock of increased resistance due to the fact that it was exposed to cyclic freezing and thawing during the Pleistocene period (Czudek 2005), significantly reduced its mechanical strength (Rapp 1960) by increasing porosity and microcracks (Le Pera et al. 2001; Ehlen 2002). This led to the fragmentation and increase in the weathering front and, as a consequence, the disappearance of some of the drained outcrops. The evolution of the Skalni Potok landforms did not end with the decline of the Ice Age. As a result of global warming, the decisive factor responsible for the frequency and size of changes within the crack set is the presence of water (compare with the S3 profile) which, in the form of rain (dissolution) or snow and/or ice (microgelivation) (Matsuoka 2001, 2008), plays a key role in contemporary weathering processes shaping the relief of the studied rock landforms.
